## **EFFICIENT NONDESTRUCTIVE EVALUATION OF PROTOTYPE CARBON FIBER REINFORCED STRUCTURES**

Authors: Samuel S. Russell  
James L. Walker  
Nondestructive Evaluation Team  
NASA Marshall Space Flight Center  
Huntsville, Alabama

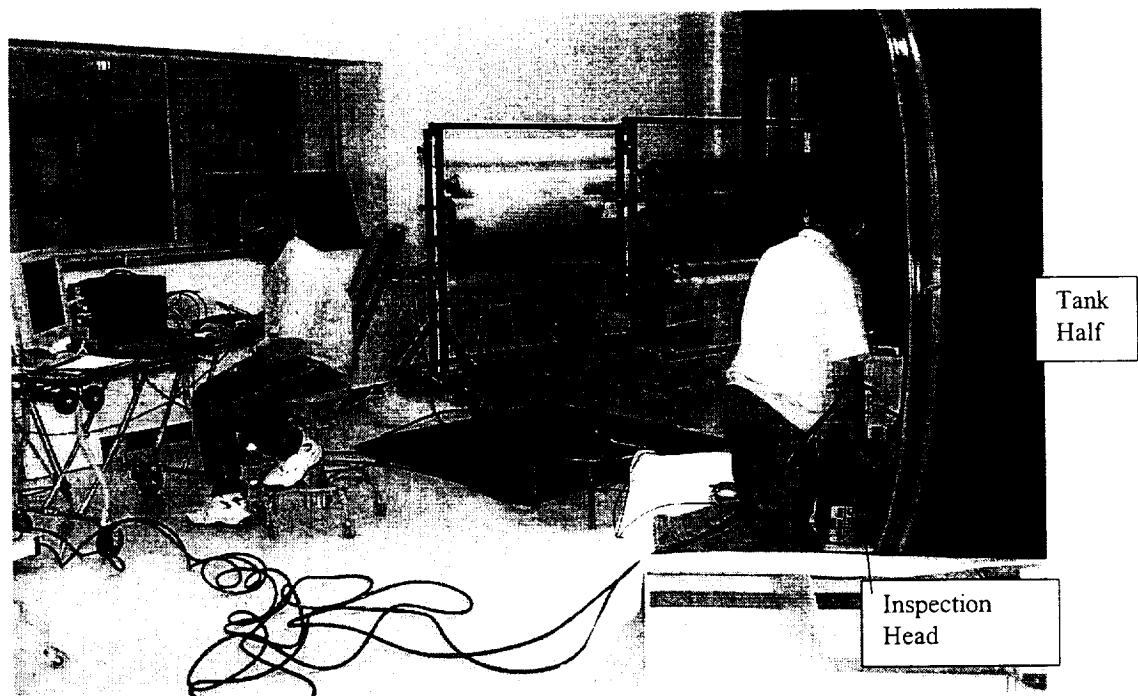
Relatively rapid inspection of composite components can usually be accomplished using thermography inspection for screening and ultrasonics to verify the condition of anomalies. Flash thermography can perform inspection with single sided access to the part using a hand held inspection head as seen in Figure 1. The inspection head contains a set of high intensity flash lamps and a high sensitivity video infrared camera. The flash lamps are similar to lamps used in portrait photography. The flash is started and timed acquisition of thermography images are performed by a computer. The infrared camera detects the temperature change on the surface as the heat input from the flash lamps flows into the part. The infrared camera is capable of detecting temperature changes of less than 0.02 degrees Celsius. Areas of different microstructure will conduct heat differently and show up as gray or color scale variations. Image manipulation and enhancement using image processing makes identification of anomalies quick and deterministic. For the inspection head shown, an area eleven inches by eleven inches is inspected at a time.

Figure 1. Flash Thermographic Inspection of Composite Tank Half

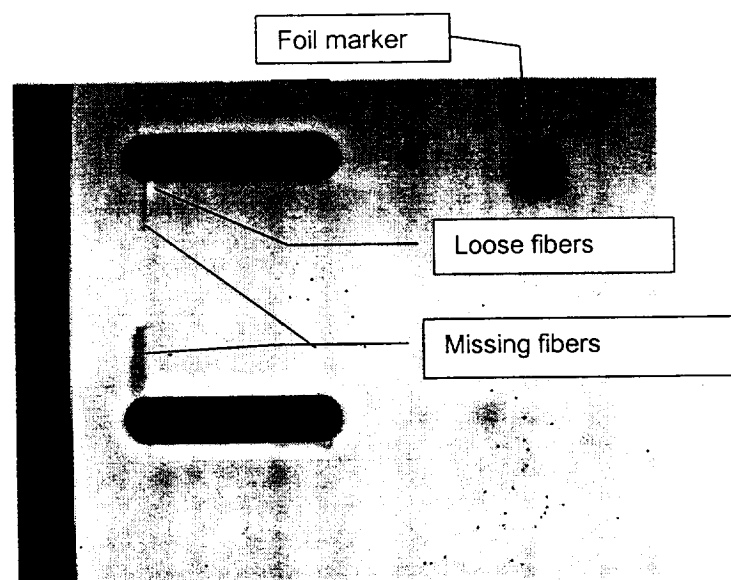
Figure 4. Thermogram of machined area of graphite epoxy tank.

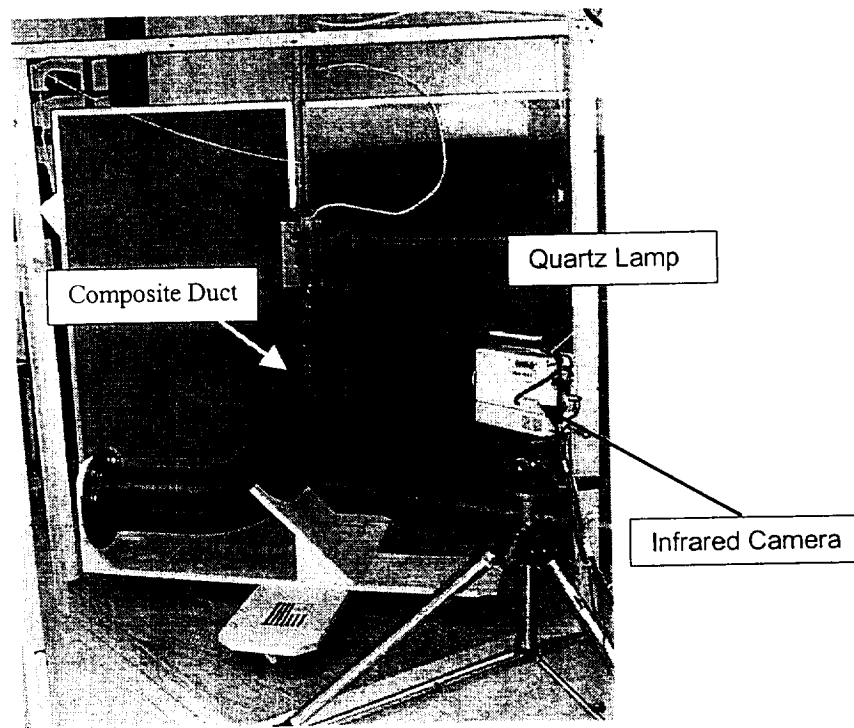
A good test for the depth of inspection when performing single sided thermography inspection if defect standards are not available is to place a piece of adhesive backed metal tape on the opposite side of the composite skin from the imager. The size of the tape should be no larger than the critical flaw size. If the inspection detects the metal tape then the inspection is adequate throughout the thickness. Thicker composite parts may require heating one side of the part and observing the opposite side. Figure 5 shows such a test being conducted on a

graphite epoxy duct. A quartz lamp is inserted into the duct and the outside surface is observed.

Figure 5. Inspection of Graphite Epoxy Duct

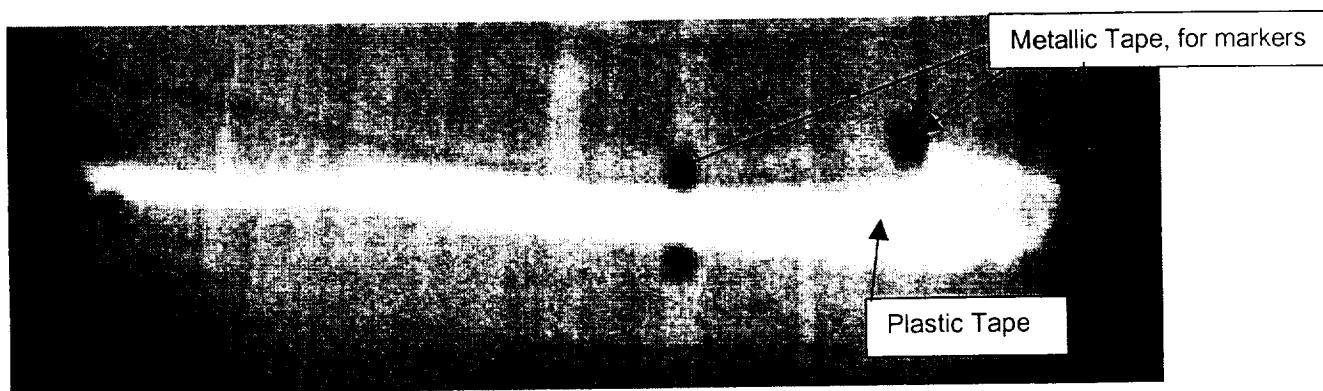
One of these composite ducts was manufactured with a piece of plastic film embedded in the laminate, see Fig. 6. Marker tape was used to map the location of this defect on the surface of the part. Also most thermography inspection software packages have a feature that will allow rapid and convenient sizing of anomalies.

Figure 6. Thermogram of composite duct with embedded foreign material, plastic tape.
